LESSONS LEARNED FROM THE HUBBLE SPACE TELESCOPE (HST) CONTAMINATION CONTROL PROGRAM

Patricia A. Hansen¹
Jet Propulsion Laboratory, California Institute of Technology

Jacqueline A. Townsend and Randy J. Hedgeland
NASA/Goddard Space Flight Center

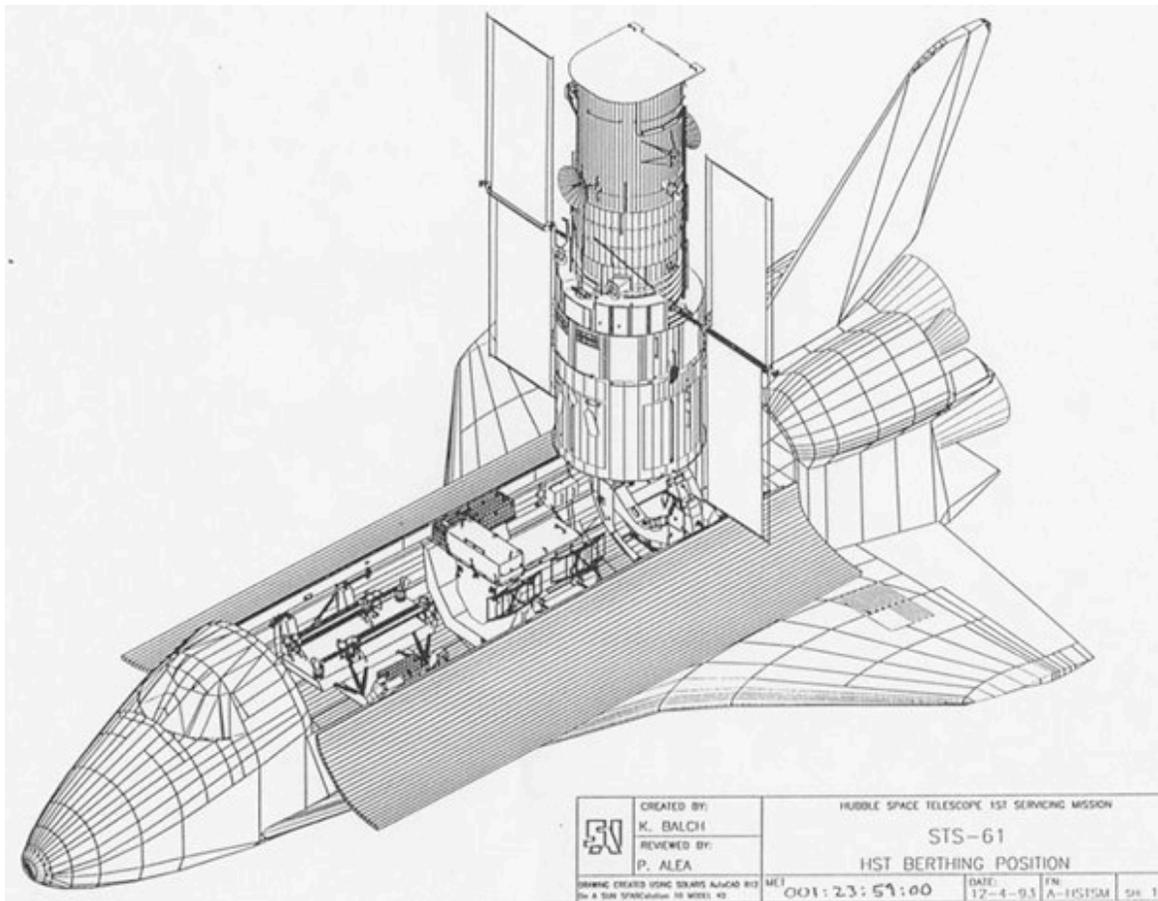
Figure 1. Servicing Mission 1 Hardware Configuration. The servicing carrier hardware is shown manifested in the Orbiter payload bay. The Solar Array Carrier is shown in the foreground, followed by the Orbital Replacement Unit Carrier. The HST is shown berthed on the Flight Support System.

The 15' long x 15' wide x 15' high Solar Array Carrier (Figure 1) functioned as the load isolation system for the Solar Array 2 during the First Servicing Mission. For the Second Servicing Mission, the Solar Array Carrier was reconfigured, renamed the Second Axial Carrier, and provided a load isolation system for the Axial Scientific Instrument Protective Enclosure which in turn provided a contamination and thermally-controlled environment for the Near Infrared Cosmic Origins Spectrograph (NICMOS).

The 5' long x 15' wide x 15' high Flight Support System was used as the maintenance platform to berth the HST to the Orbiter during the EVAs (see Figure 1). The 5' long x 15' wide x 15' high Multi-Use Lightweight Explorer provided stowage for orbital replacement units (see Figure 3). The 12' long x 15' wide x 15' high Rigid Array Carrier was used during Servicing Mission 3B to stow the Rigid Solar Arrays (see Figure 3). Once the Rigid Solar Arrays were integrated onto the HST during the servicing mission, the Rigid Array Carrier was used to stow the de-integrated Solar Array-2 during the rest of the mission (including descent).

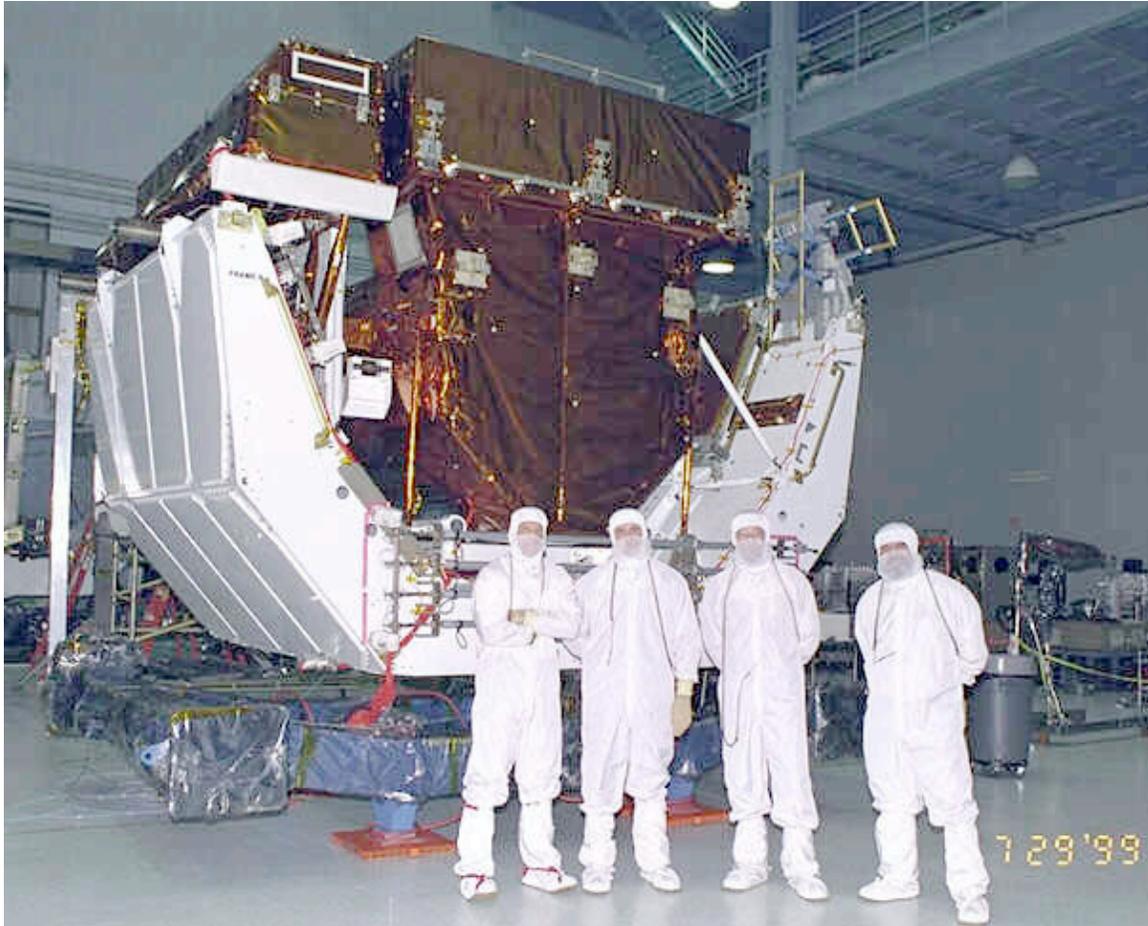
Figure 2. The Orbital Replacement Unit Carrier. The Orbital Replacement Unit Carrier is shown with the Fine Guidance Sensor SIPE forward. Orbital Replacement Unit Protective Enclosures are shown on the shelf (left).

The most contamination sensitive carrier is the 12' long x 15' wide x 15' high Orbital Replacement Unit Carrier (Figures 1 and 2). The Orbital Replacement Unit Carrier provided a load isolation system for an Axial Scientific Instrument Protective Enclosure (SIPE) and the Radial SIPE. These SIPEs, collectively known as the BISIPE, provided a contamination- and thermally-controlled environment for stowed scientific instruments. For the First Servicing Mission, the Corrective Optics and Space Telescope Axial Replacement (COSTAR) and Wide Field and Planetary Camera II (WFPC-II) were stowed in the Axial and Radial SIPEs, respectively. For the Second Servicing Mission, the Axial SIPE held the Space Telescope Imaging Spectrograph (STIS) and the Radial SIPE was reconfigured to hold a Fine Guidance Sensor and was renamed the Fine Guidance Sensor SIPE. Because of the optical sensitivity of the scientific instruments and Fine Guidance Sensors, the Second Axial Carrier and the Orbital Replacement Unit Carrier were the most contamination-sensitive carriers.

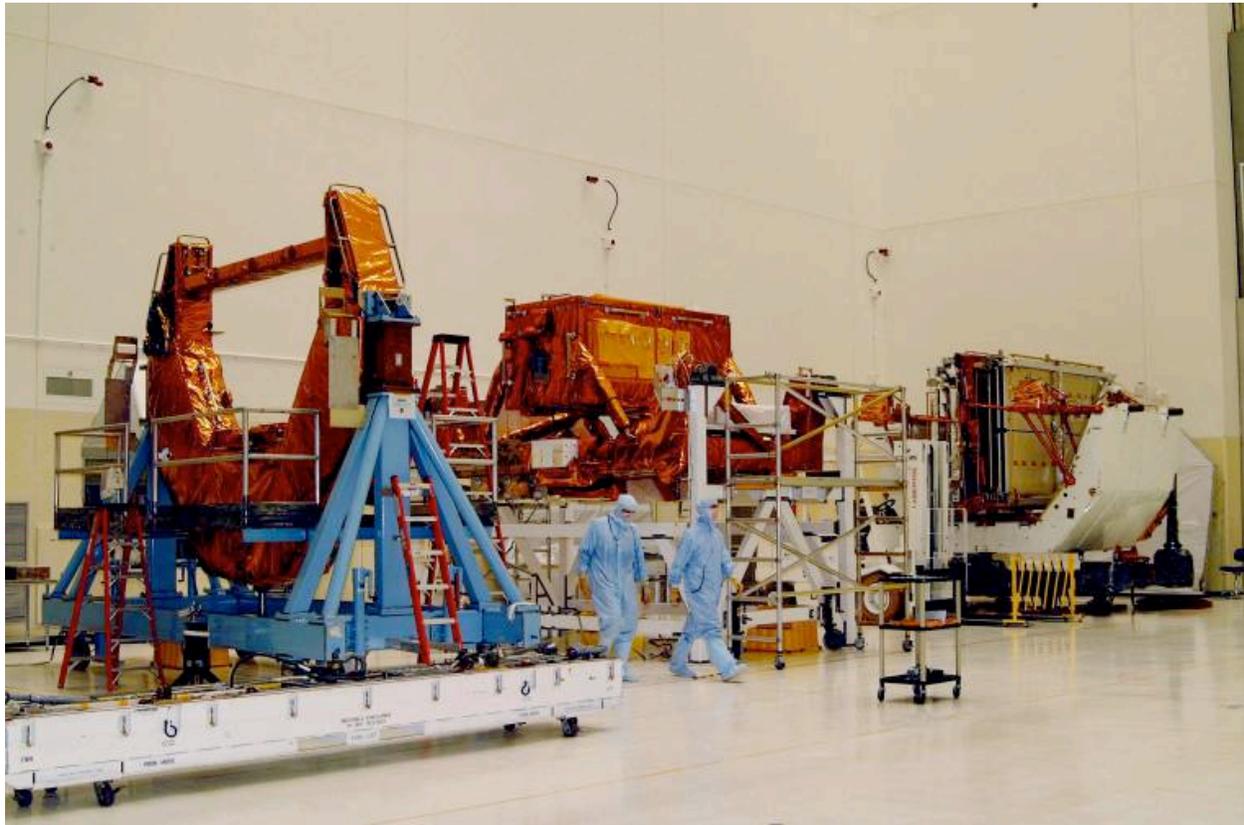
Figure 3. The Servicing Mission 3B servicing carriers –Multi-Use Lightweight Explorer (left foreground), Second Axial Carrier (center), and Rigid Array Carrier (right). The Axial Scientific Instrument Protective Enclosure (large rectangular box) is shown mounted on the Second Axial Carrier. The Rigid Solar Arrays are shown stowed on the Rigid Array Carrier.

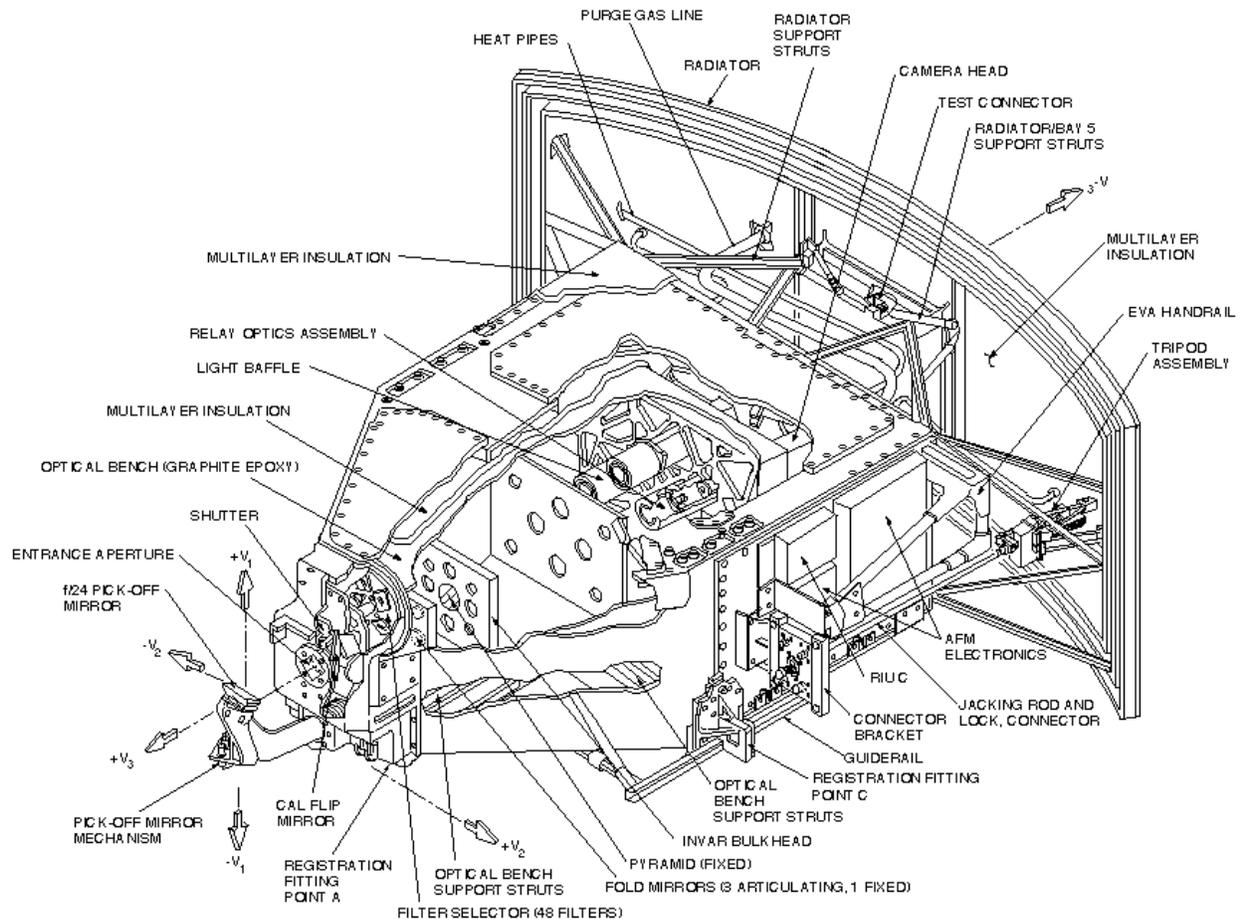
Figure 4. Wide Field and Planetary Camera II. The Wide Field Planetary Camera II is shown; however the optical train and overall instrument layout was identical to that of the Wide Field Planetary Camera I.

The WFPC-1 was one of the original scientific instruments deployed on HST. It was replaced with the Wide Field and Planetary Camera II (WFPC-2) during the First Servicing Mission, which provided upgraded science capability. Post-mission inspection of the WFPC-1 pick-off mirror (see Figure 4) showed some haziness when viewed with a bright light. A Failure Review Board was convened to determine the cause of the haziness and to recommend remedial action to the HST Project to preclude contamination of other optical surfaces.
